State of California — The Resources Agency
DEPARTMENT OF PARKS AND RECREATION
PRIMARY RECORD

*Resource Name or #: K30

c. Address 8673 Salmon Avenue

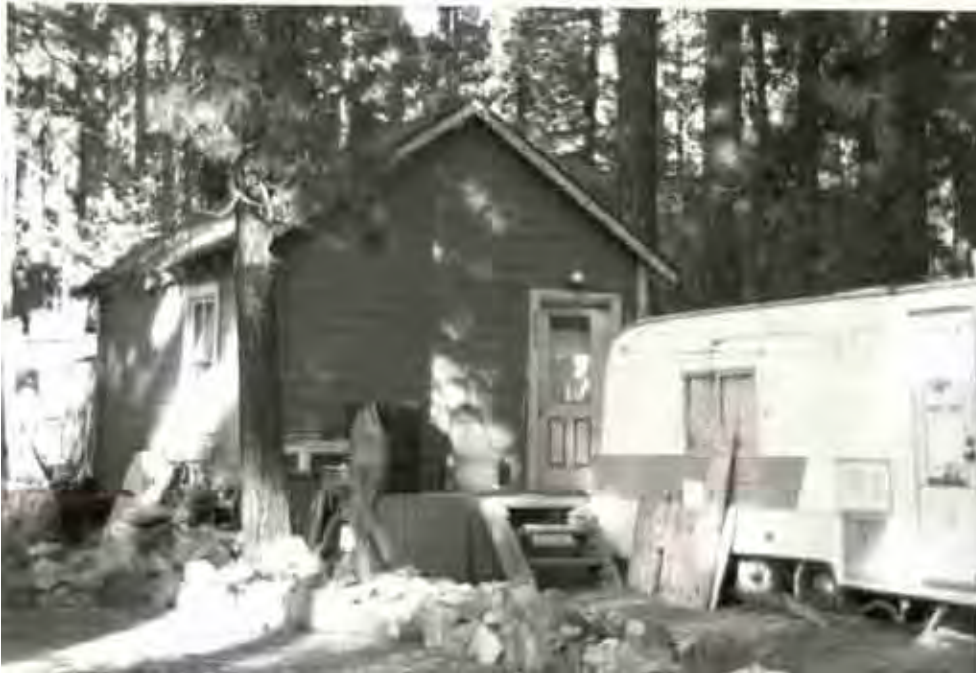
P5b. Description of Photo:
090-126-024, Building A, View NE.
Roll KBB4, Fr. 7. 11-14-02, 2:55 PM.

Building A is a one-story rectangular plan wood frame house. It has an end-gable roof with open eaves and exposed rafters. Walls are sheathed with wood V-rustic siding. Windows are wood 1/1 sash. The door is wood panel with one light. It has a small open front porch. The building appears to be unmodified.

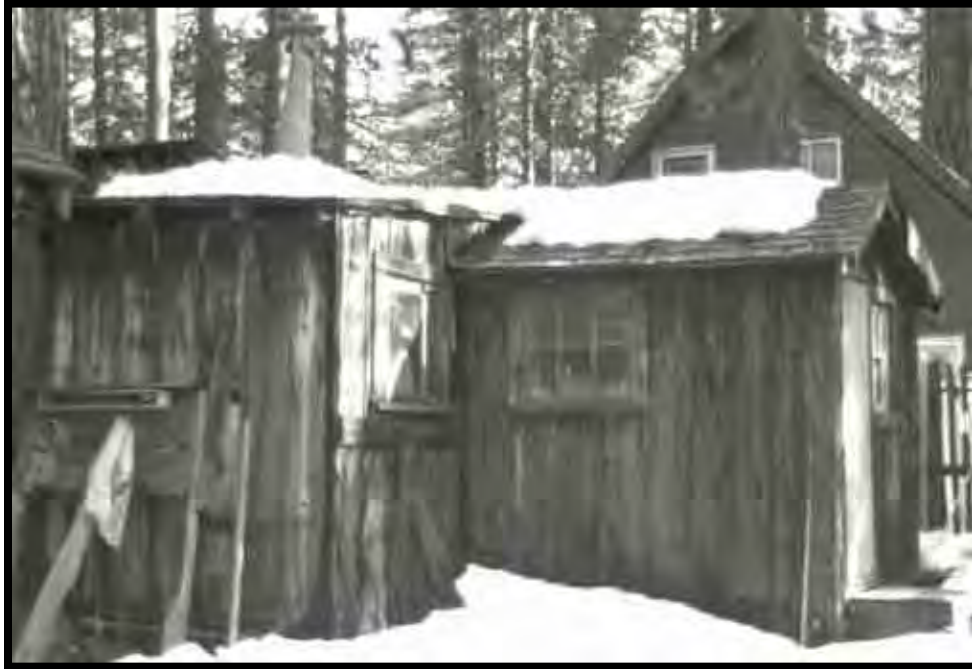
090-126-024, Building B, View NE. Roll KBB6, Fr. 26. 01-17-03, 10:28 AM.

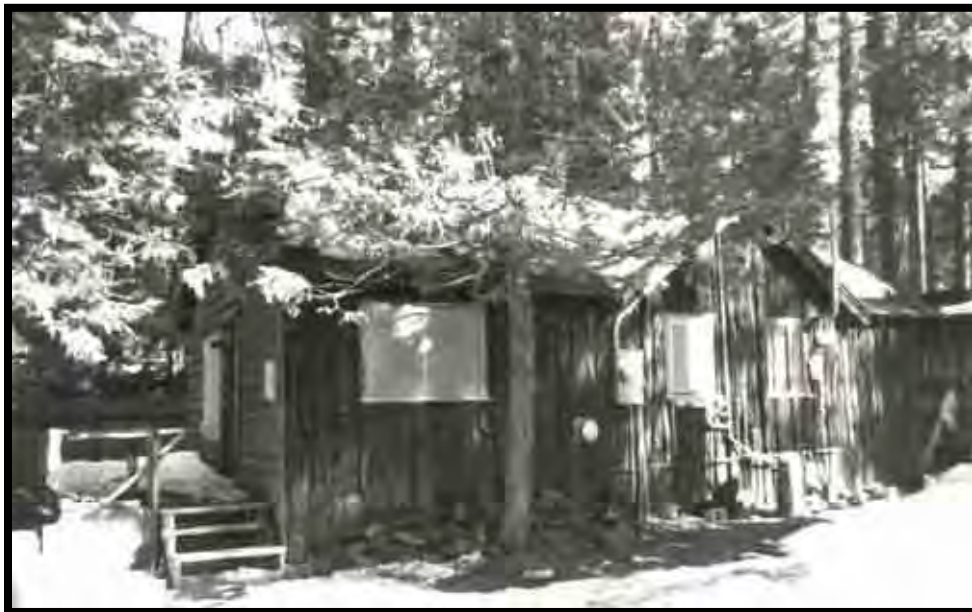
Building C has had all windows and the door replaced c.1990s.

090-126-024, Building C, View NE. Roll KBB6, Fr. 27. 01-17-03, 10:29 AM.

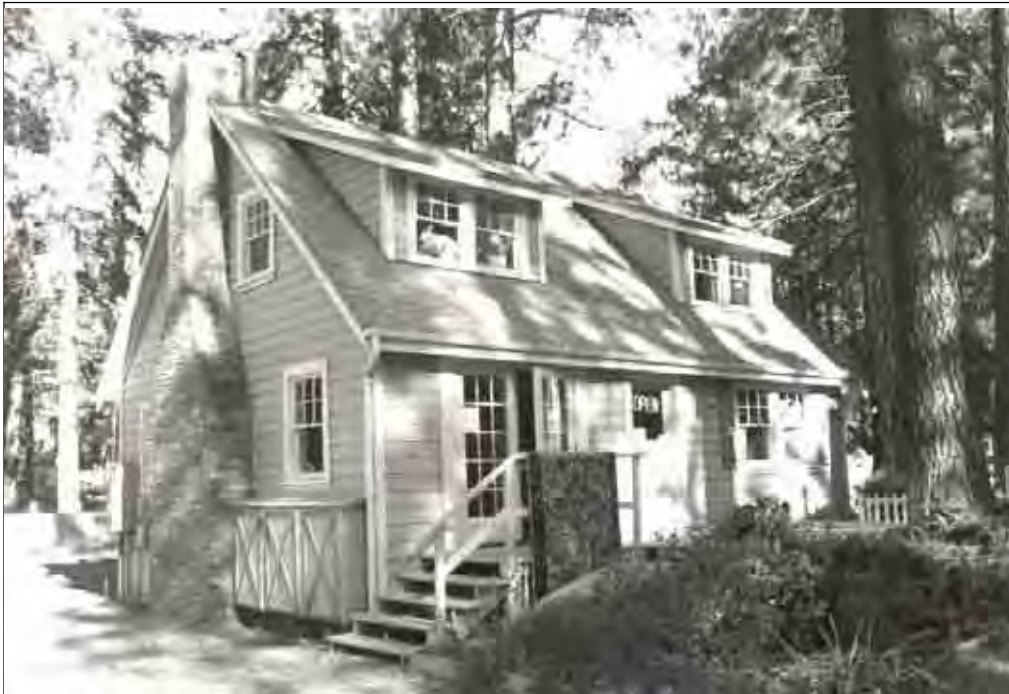
P5b. Description of Photo:
090-133-015, Building A, View NE.
Roll KBB3, Fr. 28. 11-14-02, 1:34 PM.

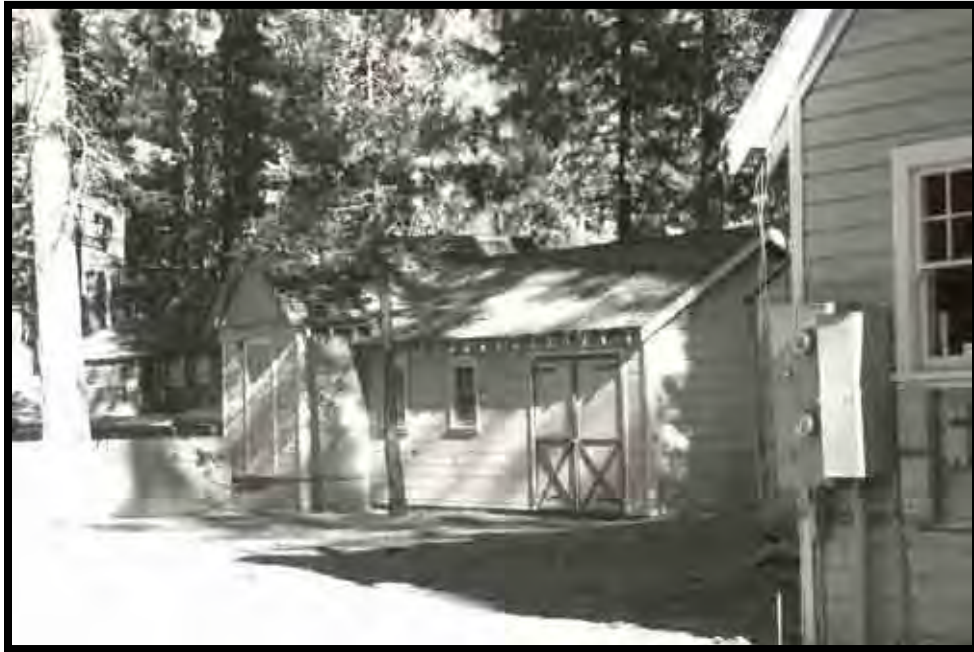
Building B is a one-story L-plan wood frame house now used for storage. It has a cross-gable roof with open eaves and exposed rafters, clad with milled wood shingles. Walls are sheathed with painted V-rustic siding. Windows are 4/2 and 1/1 wood double-hung. Doors are flush. Carriage-house doors are made of V-rustic siding. This building appears to have been made by joining two small rectangular buildings. A covered porch is on the east side of the building.

090-133-015, Building B, View NE. Roll KBB3, Fr. 29. 11-15-02, 1:36 PM.

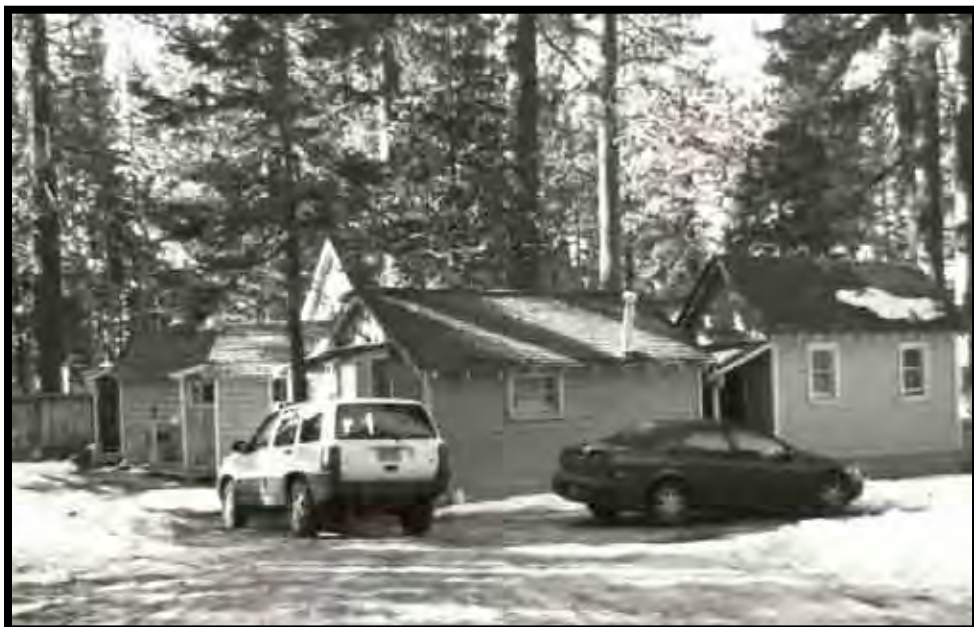
Building C is a one-story rectangular plan wood frame house. It has an end-gable roof with exposed rafters and open eaves, clad with composition shingles. Windows are 4/1 wood double-hung and the door is clad with V-rustic siding. It has a small covered entrance porch with a shed roof. The building appears to be unmodified.

090-133-015, Rear of Building B at right, Building C to left.
Roll KBB6, Fr. 25. 01-17-03, 10:15 AM.

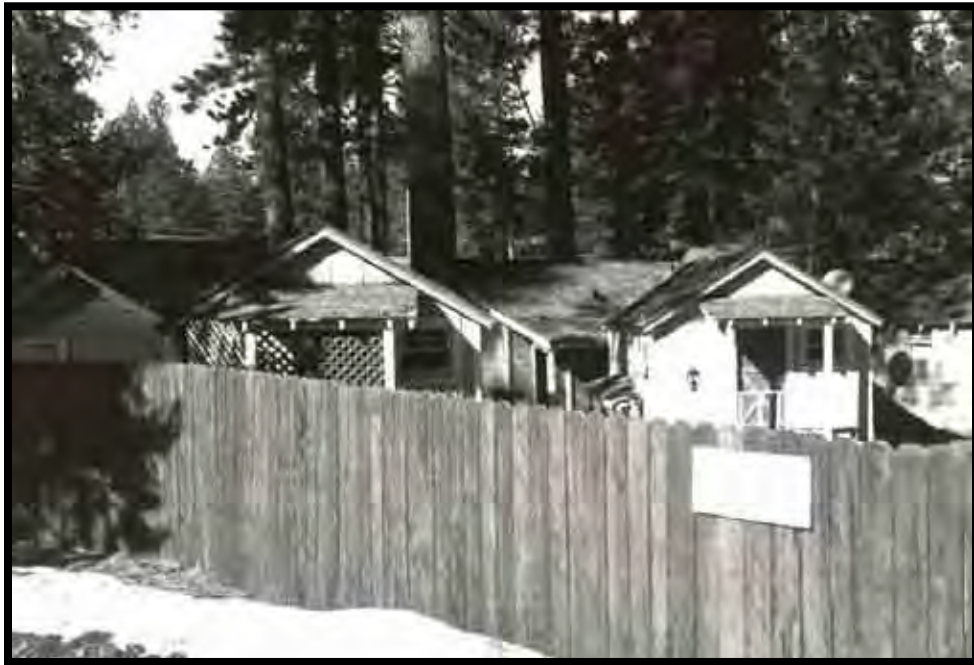
Buildings D and E are nearly identical. They are one-story rectangular plan wood frame houses. They have end-gable roofs with exposed rafters and open eaves, clad with milled wood shingles. Windows are 4/1 and 1/1 wood double-hung and wood four-light casement. Doors are clad with V-rustic siding. Each building has a small covered entrance porch with a shed roof. The buildings appear to be unmodified except for some wood lattice attached to the porch on Building E.

090-133-015, Buildings D and E, View NW.
Roll KBB6, Fr. 29. 01-17-03, 12:30 PM.

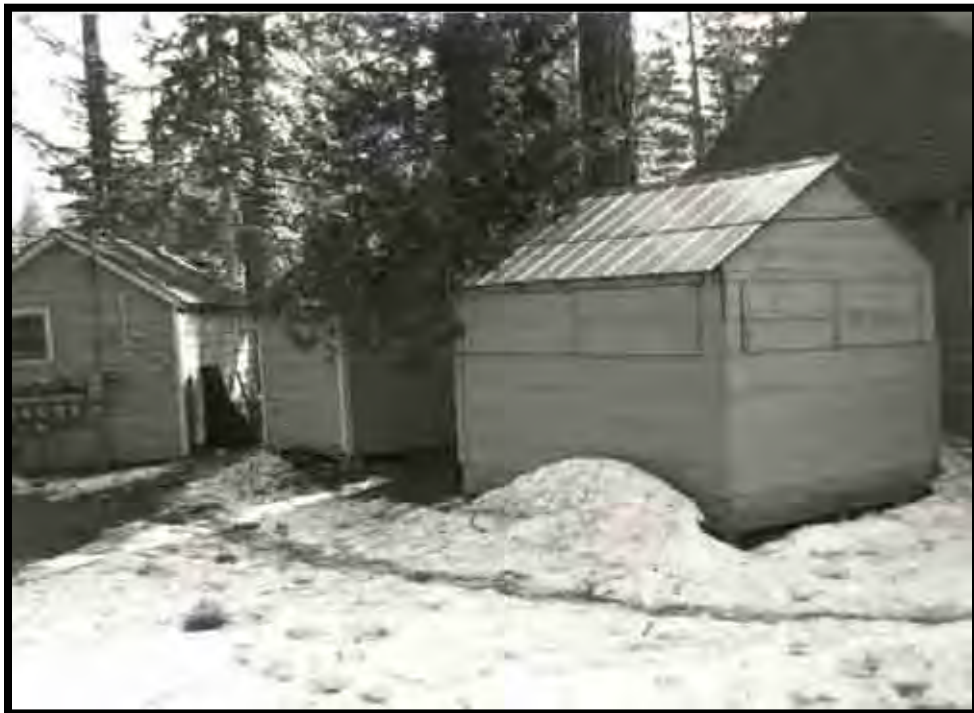
There are also two small outbuildings located immediately north of Building A. The eastern of these is a shed with a gable-roof clad with milled wood shingles. It is sheathed with wood drop rustic siding. The western of these appears to formerly have been a concession stand, since it has horizontal full-length plank shutters. It has a gable roof clad with aluminum panels. Walls are clad with horizontal board and batten siding.

090-133-015, Sheds at rear of Building A, View SE.
Roll KBB6, Fr. 30. 01-17-03, 12:35 PM.

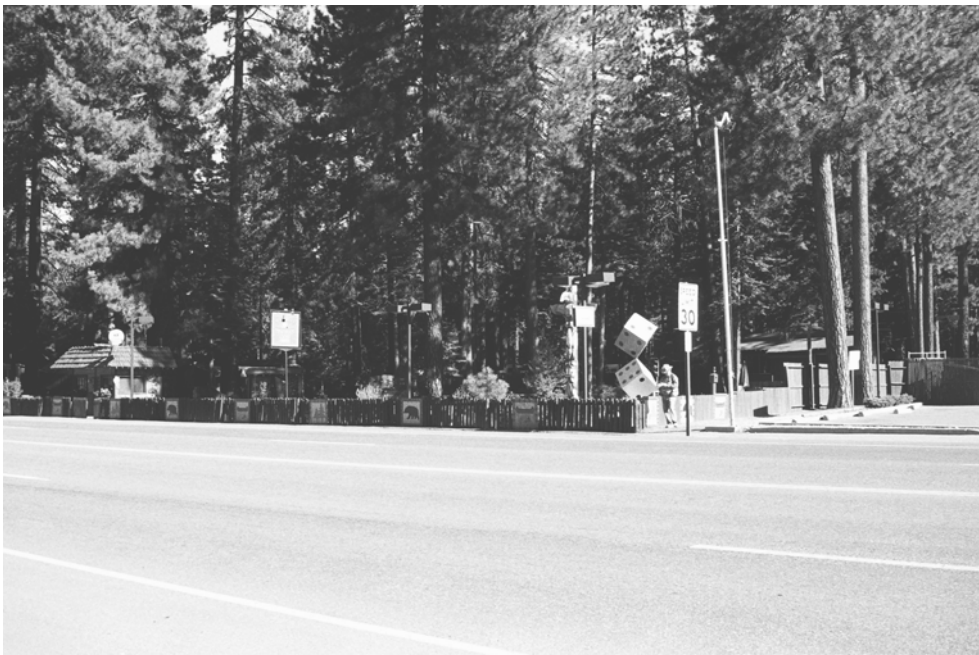
***P3a. Description:** The property is a wooded lot occupied by a meandering miniature golf course. Two small buildings are present. The restroom occupies a rectangular plan wood-frame building. It has a side-gable roof clad with composition shingles. Walls are sheathed with wood V-rustic siding. Windows are metal sliders.

Overview, view N.

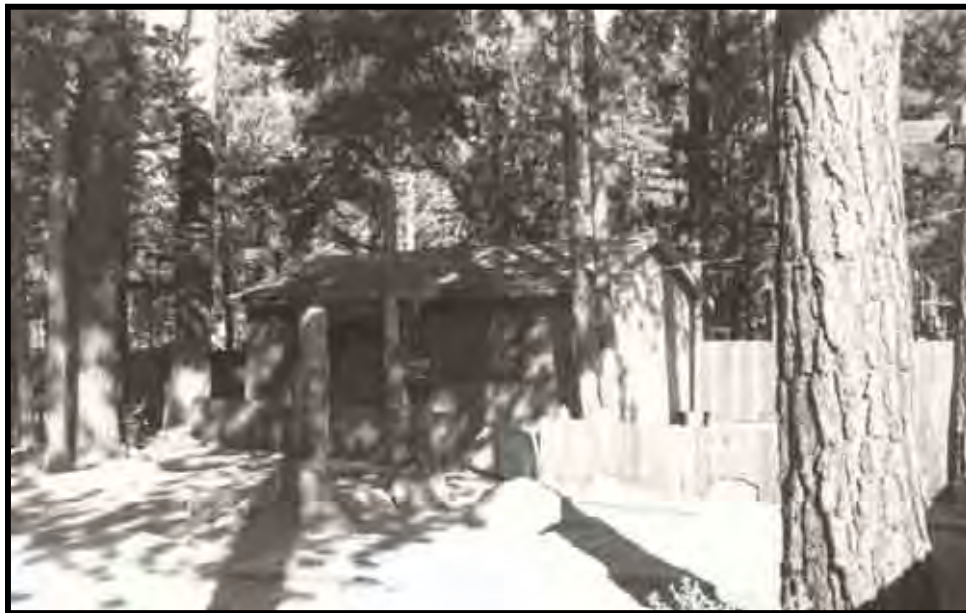
Restroom, view NNW. Roll KBB1, Fr. 11, 10-30-02, 10:25am.

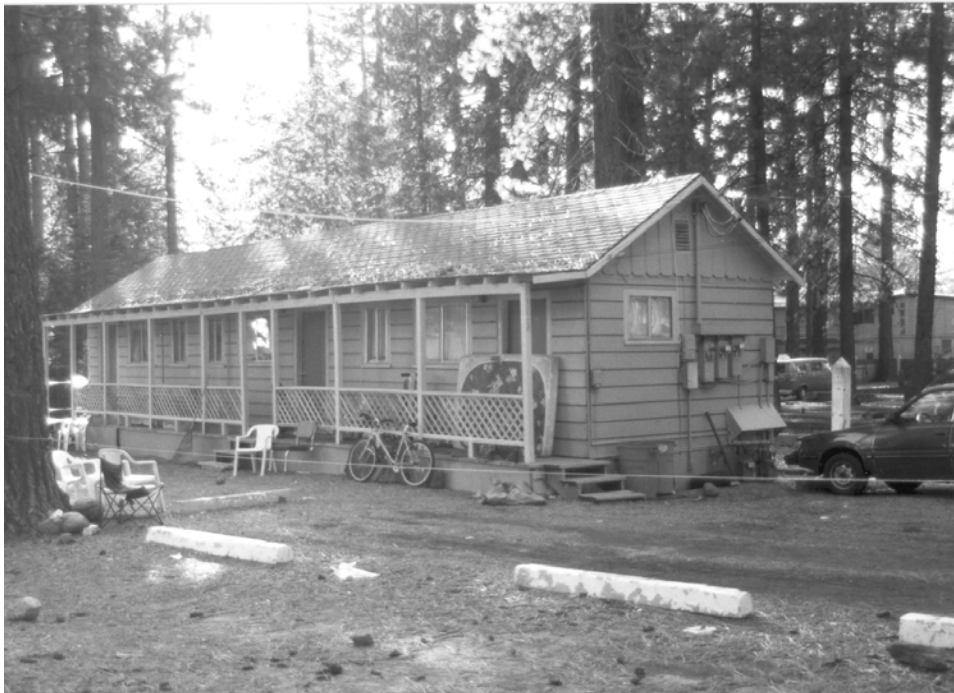
*P3a. Description: This building is a one-story rectangular plan wood frame apartment building. It has a side-gable roof with exposed rafters and open eaves, clad with composition shingles. Walls are sheathed with horizontal painted custom milled 2x8 inch drop rustic siding. Gable ends are sheathed with beaded vertical planks. Windows are metal sliders and doors are flush. A full-length shed-roof porch runs along the east side of the building. Porch pillars are simple. Recent lattice is incorporated into the porch railings and the skirting under the porch is plywood.

P5b. Description of Photo:
090-133-008, View SW.
Roll KBB4, Fr. 5 11-14-02, 2:45 PM.

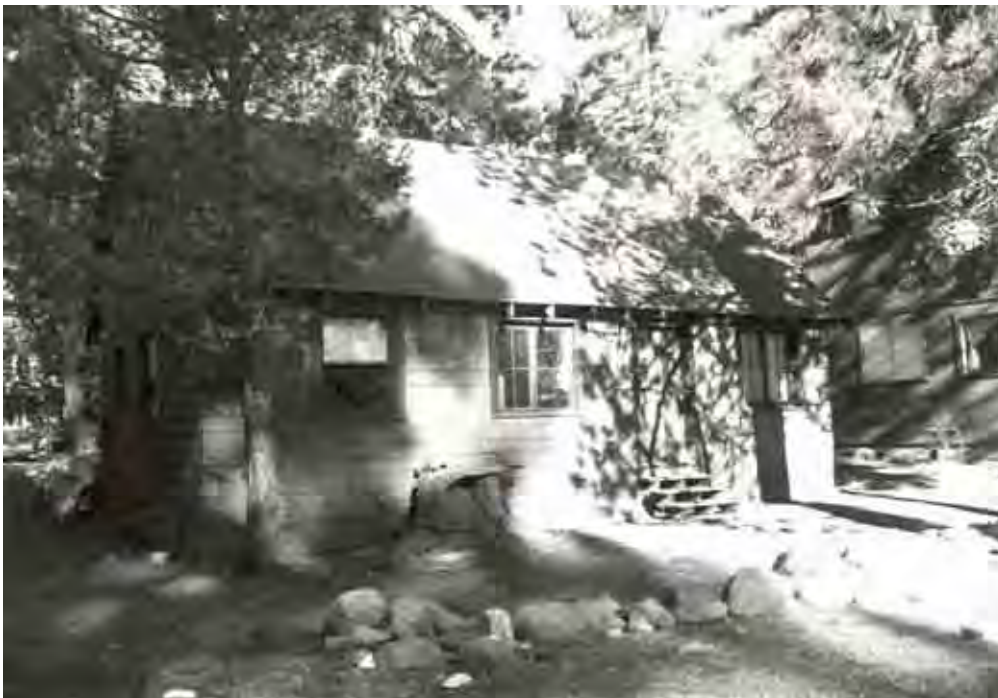
090-192-003, View NE.

*P3a. **Description:** This building is a 1½ story rectangular plan wood frame house. It has a cross-gable roof with exposed rafters and open eaves, clad with composition shingles. Walls are sheathed with milled wood shingles and wood V-rustic siding. Windows are wood, including 1/1 double-hung and paired four light casement. The doors are sheathed in log cabin siding. A small rear addition appears to be old. Native trees are on the grounds.

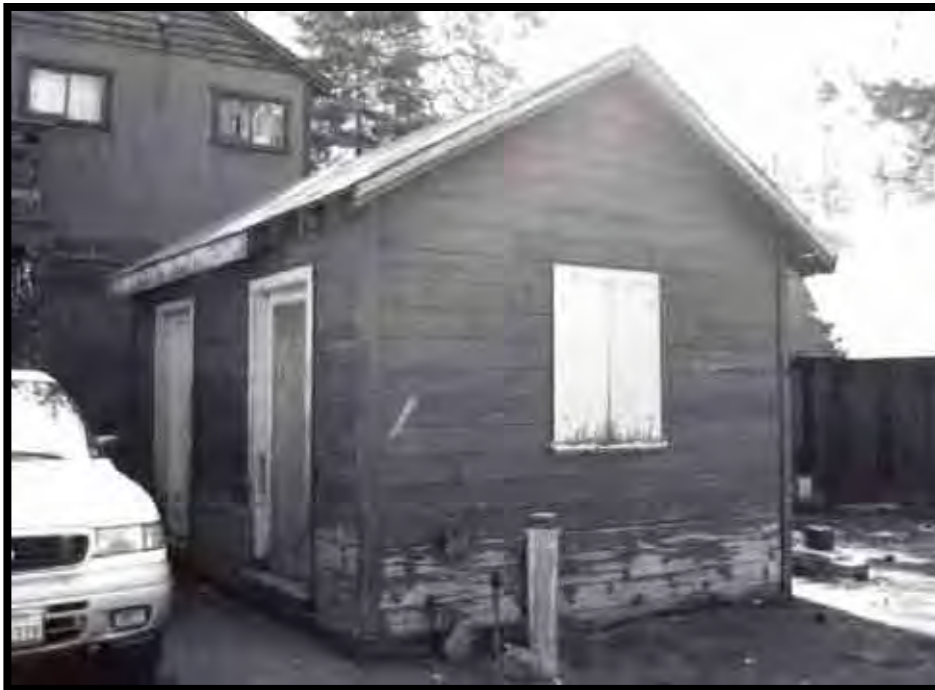
Building B is a small one-story rectangular plan wood frame outbuilding. It has a side-gable roof with open eaves and exposed rafters, except where a portion of fascia has recently been added. The roof is clad with composition shingles. Walls are sheathed with painted V-rustic wood siding. Windows are shuttered. The doors are wood panel. The building is mounted on mass-produced truncated pyramid-shaped cast concrete piers. The building has symmetrically-placed twin doors and venting suggesting former use as a restroom.

Building B; View SW. Roll KBB10,
Fr.20. 03-12-03, 1:50 PM.

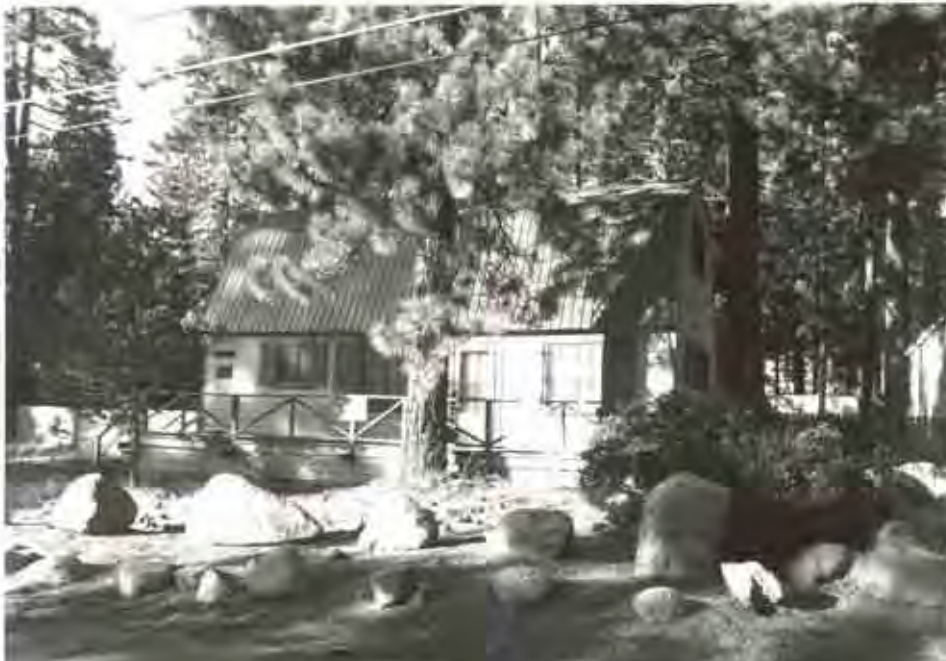
090-191-018 View NW.

*P3a. Description: This building is a 1½ story rectangular plan wood frame house. It has a gambrel roof clad with recent standing-seam metal. Walls are covered with V-rustic siding. Windows are wood 6 and 4 light paired casement with operable shutters. The door is wood with lights, partly obscured by a recent storm door. An open porch with wood truss railing runs along the south side of the house. The yard is fairly unaltered and supports native trees.

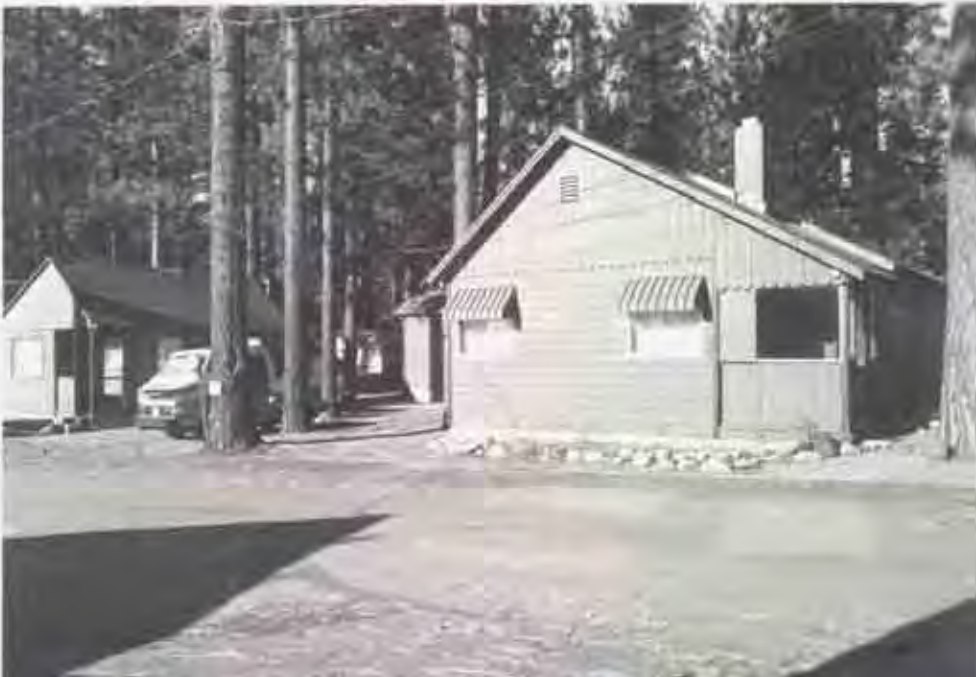
Overview. Building A at right, Building D at left, View NW.

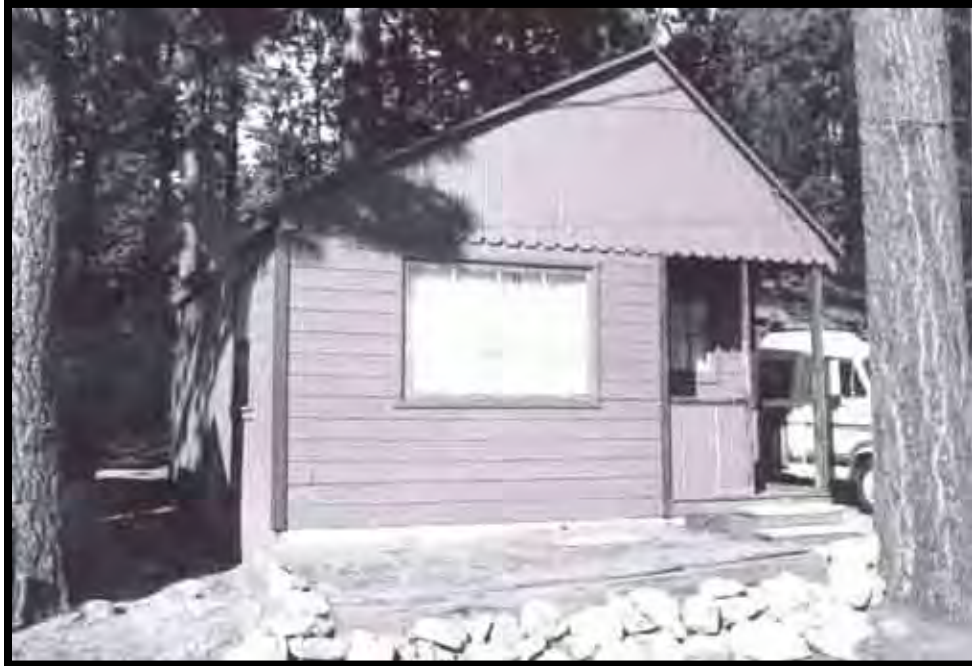
Building D is a one-story rectangular plan wood frame house. It has a gable roof with open eaves and exposed rafters, clad with composition shingles. The building has an inset corner entry porch. Walls are clad with wood V-rustic siding. Windows are wood 4/4 and 4/1 double-hung, 8 light fixed, and 12 light fixed. It has a panel door. There do not appear to be any modifications.

090-192-053 Building D, View NE.
Roll KBB10, Fr.22. 03-12-03, 3:41 PM.

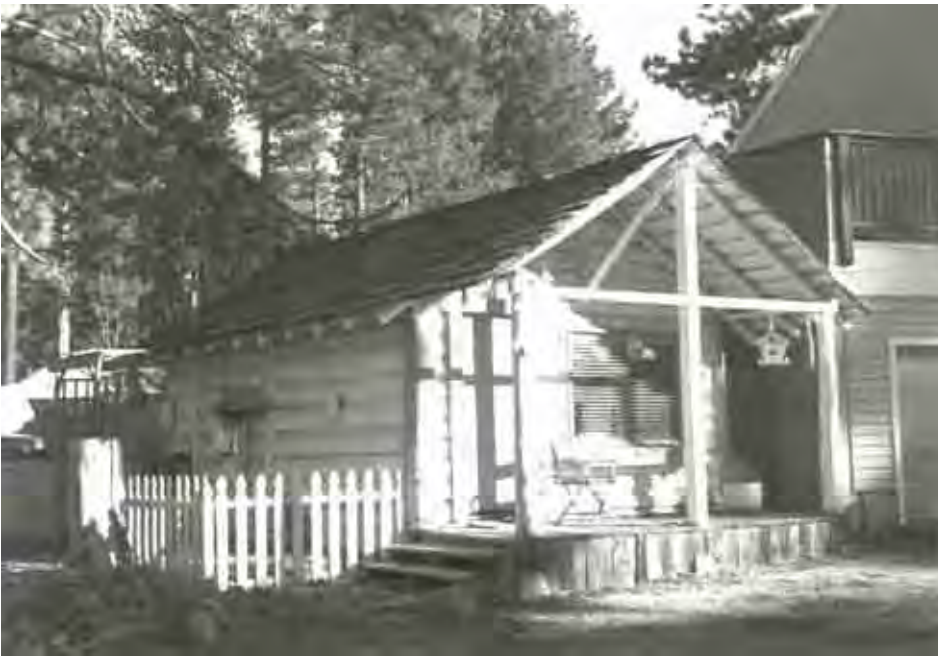
P5b. Description of Photo:
Back porch from Brockway Vista; View
NE; Roll KBB6, Fr.8,
01-13-03, 9:20 AM.

*B6. Construction History: Effective Year is 1924. The Year Built is not in the Assessor's database. The building is accurately portrayed on the 1936 highway construction map. One door has been blocked, but that modification is likely 1920s-1930s. The only recent (c.1990s) modification appears to be replacement of one window.

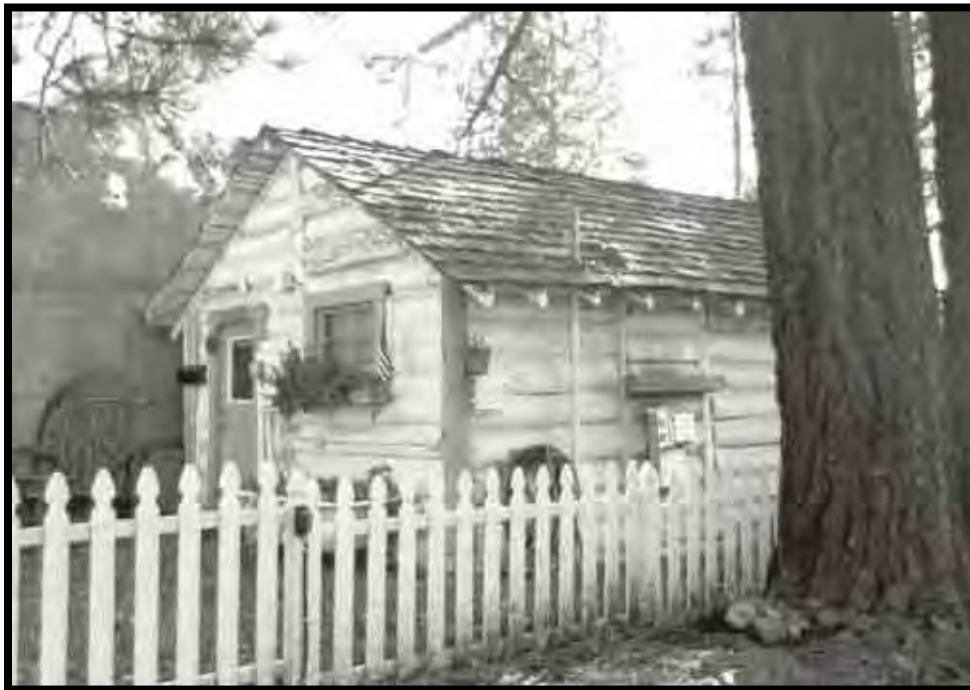
Front and west side from Secline Street, View SE;
Roll KBB3, Fr. 3, 11-14-02, 10:13 AM.

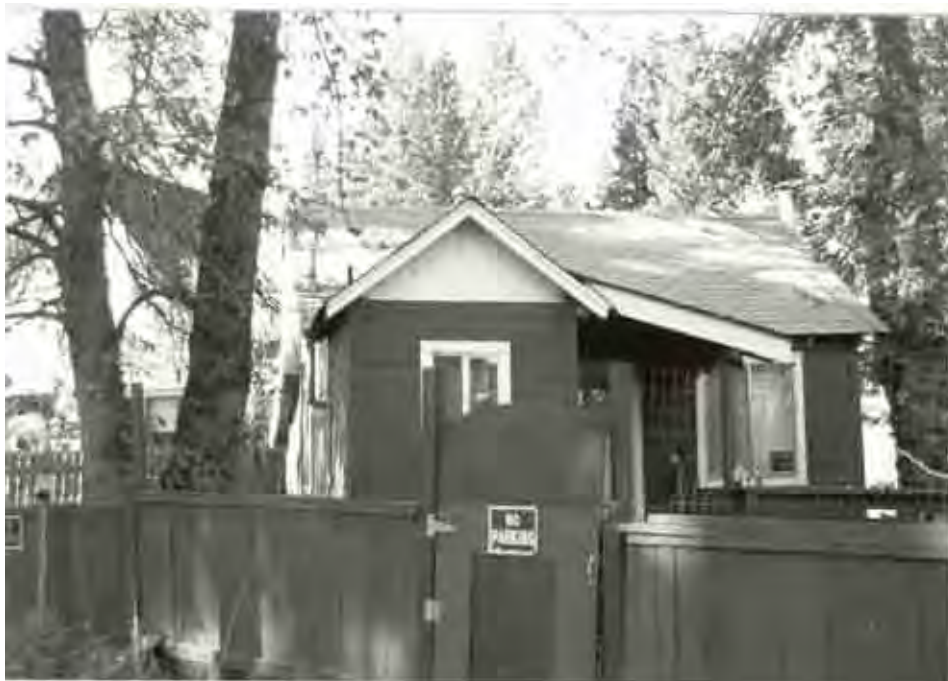
090-072-019, View NW.

*P3a. Description: This building is a one-story L-plan wood frame house. It has a gable roof with exposed rafters and open eaves, clad with composition shingles. Walls are sheathed with painted wood V-rustic siding. The building has recent aluminum sliding windows and a wood one-light panel door. A recent shed roof has been installed over the entrance and a large dog door cut into the front door.

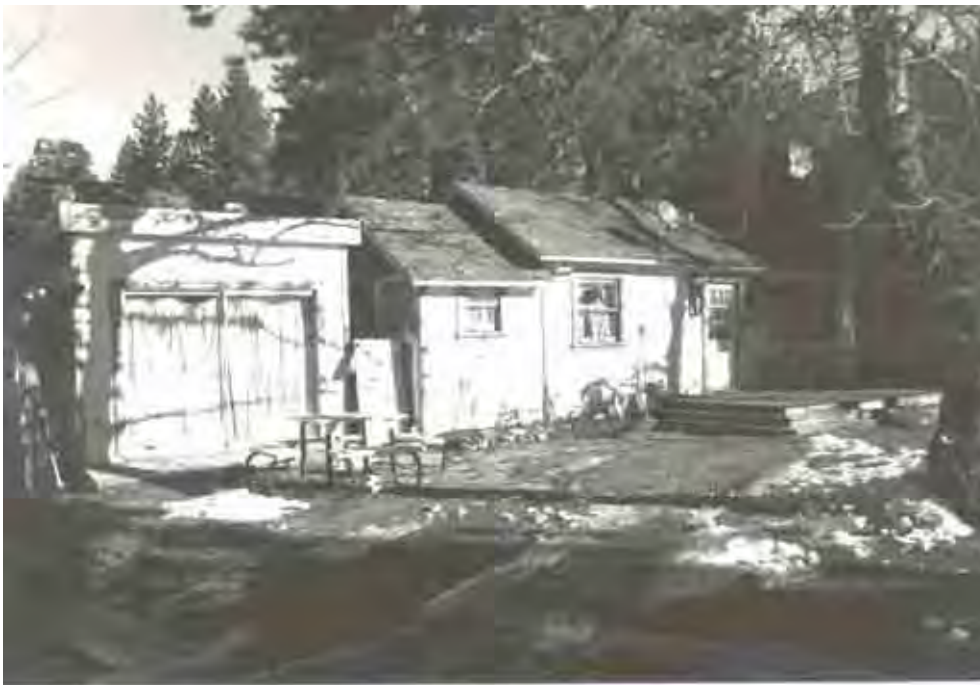
090-072-016, View NE.

*P3a. Description: This building is a one-story rectangular plan wood frame house. It has a side-gable roof with open eaves and rafter ends partly obscured by a fascia, clad with composition shingles. Walls are sheathed with painted V-rustic wood siding. The building has wood 1/1 double-hung windows. The only modification is a recent wood X-panel door with nine lights. The building is set on a lot with a garage, lawn, native trees, and a recent deck.

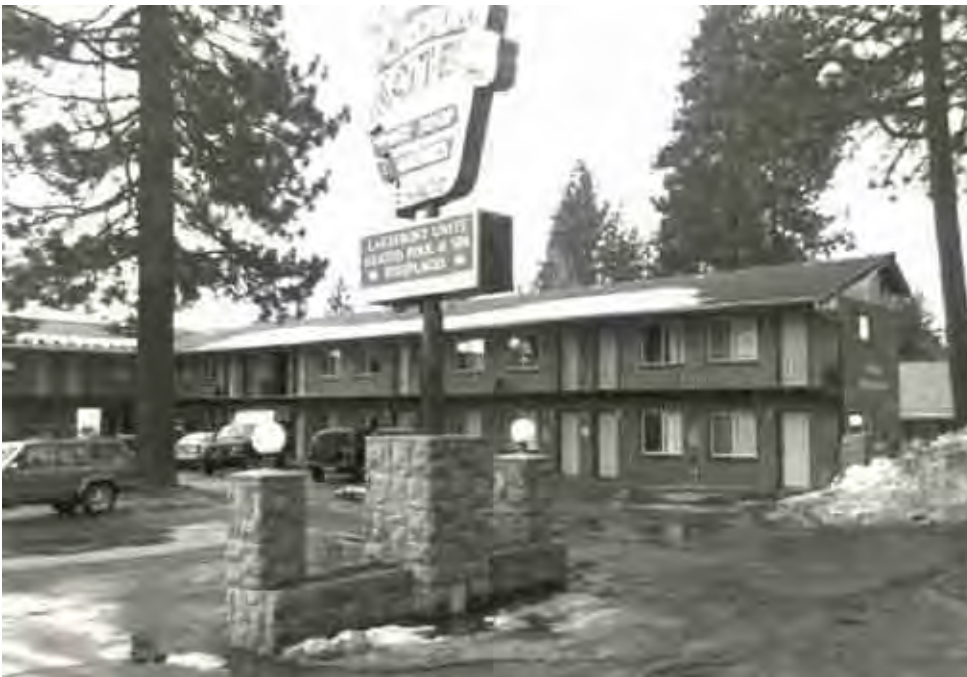
P5b. Description of Photo:
090-072-027, West wing, View SW.
Roll KBB6, Fr. 1. 01-13-03, 9:50 AM.

*B6. Construction History: Assessor's Year Built is 1955. The motel is shown on the 1956 CSAA map. Additions (c.1980s) may include much of second floor, rear, and entrance. Nearly all windows and doors appear to be recent (c.1990s) replacements.

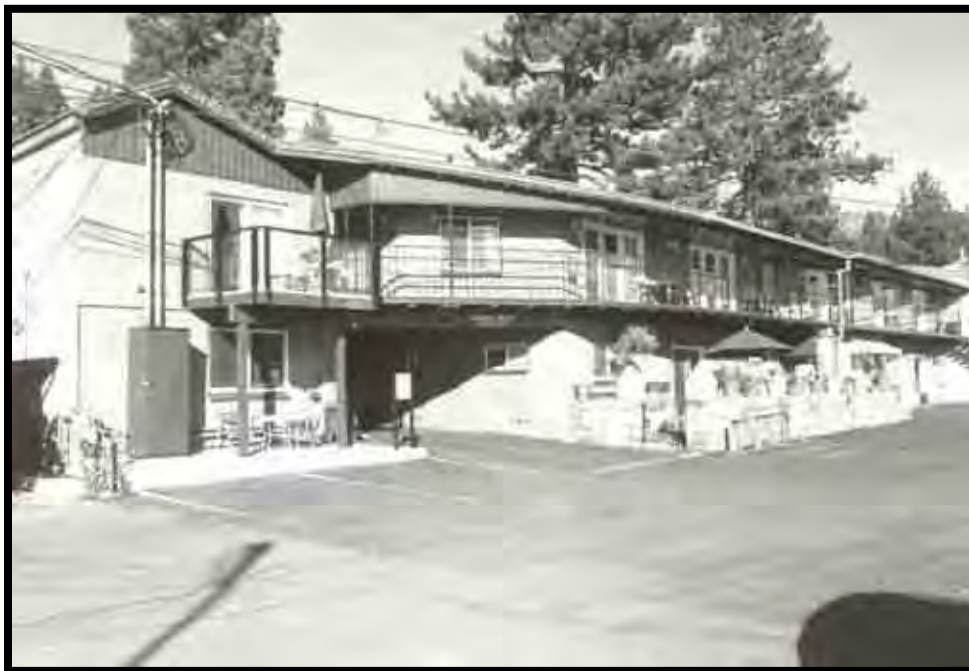
*B8. Related Features: Multi-colored stone wall around rear patio is similar to Stewart Indian School masonry found throughout the Tahoe Basin. An elaborate faux ashlar planter and light fixture forms the base of the sign on SR 28.

090-072-027 Rear, at Brockway Vista Ave., View NW.
Roll KBB2, Fr. 29. 10-31-02, 2:35 PM.

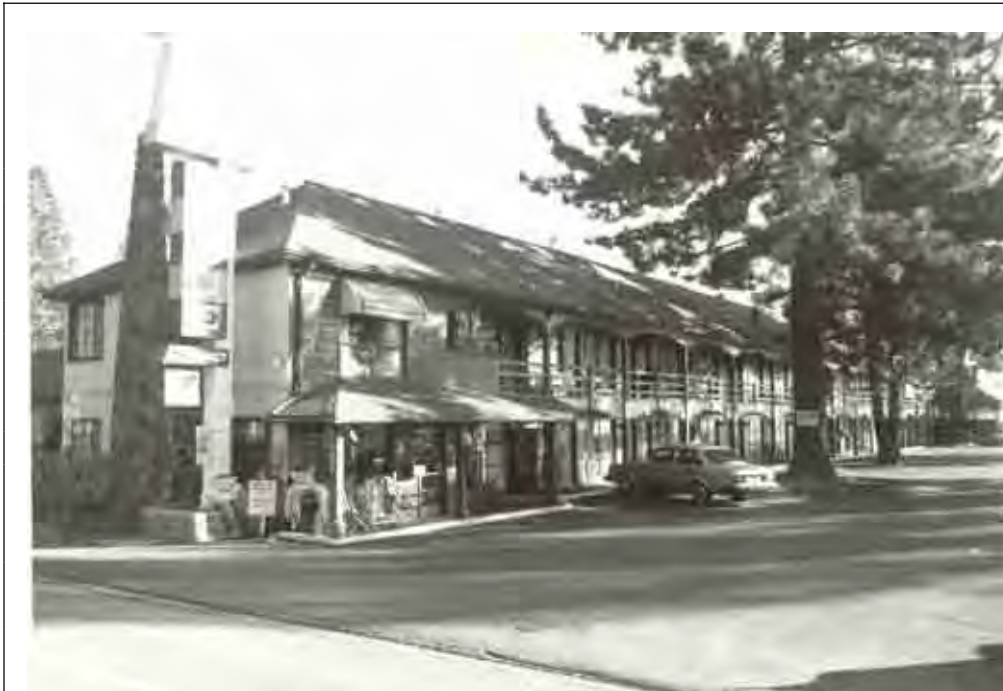
090-072-026, View SE.

***P3a. Description:** This building is a two-story rectangular plan strip motel. It has a hip roof with open eaves and exposed rafter tails partly covered by a fascia, clad with composition shingles. Walls are sheathed with unpainted V-rustic siding. The building has a variety of fixed and casement windows, generally with six or eight lights. The office door has five lights, the rest of the doors are flush. As comparison of the attached historic advertisement and recent photo shows, the building is almost unmodified. The largest addition is a gazebo at the rear of the building. The historic sign has been replaced and a canopy placed over one window.

*B6. Construction History: Assessor's Year Built: 1952, confirmed by first appearance in phone books in 1953. Owner-managers noted in 1955-56 phone books are Marcia and Malin Petz. Modifications include a c.1990s gazebo, sign, and canopy over one window.

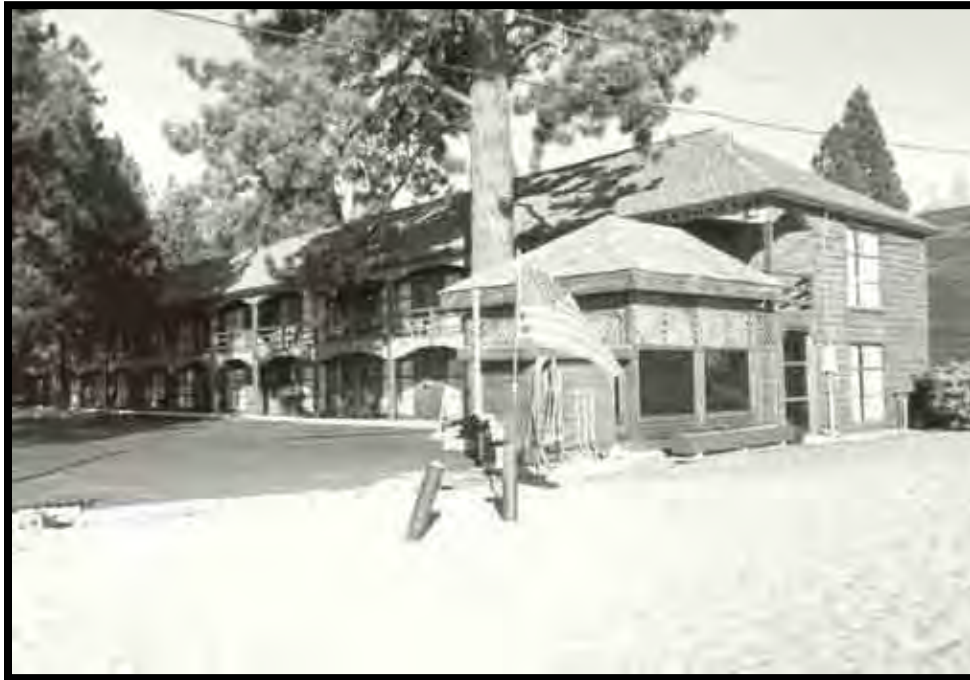
090-072-026 Rear at Beach, Gazebo in foreground. View NE. Roll KBB2, Fr. 32, 10-31-02, 2:47 PM.

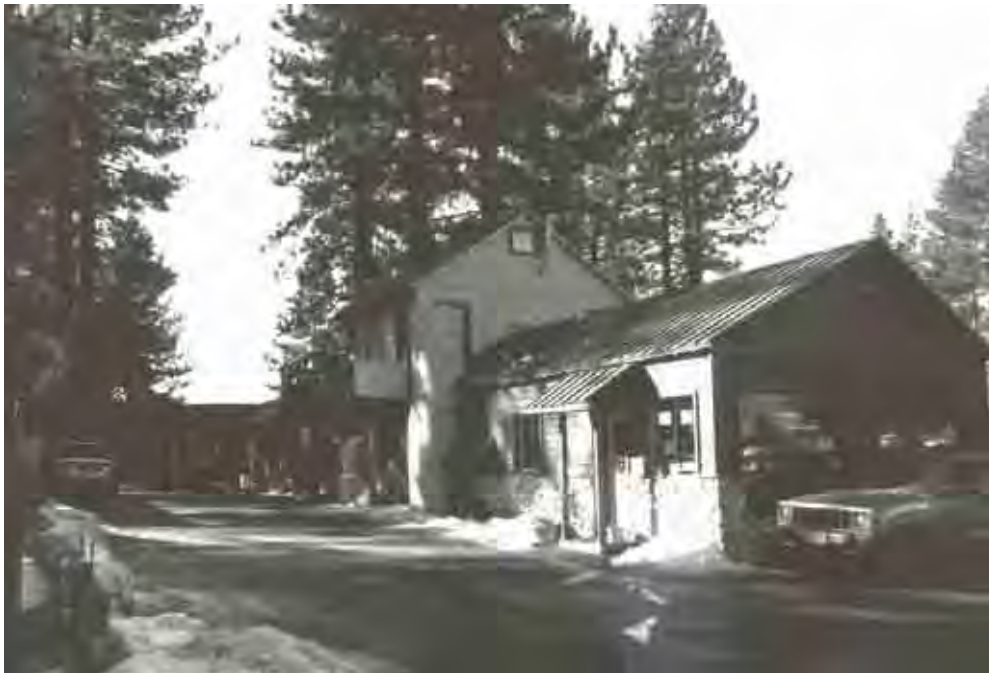
***P3a. Description:** This property includes two buildings on a paved lot. No native trees grow on the lot. Building A is a rectangular plan structure with a side gable roof clad with recent standing seam metal panels. The front (north) half of the building is one-story, occupied by the video store. It is of straight corner cinderblock construction sheathed with wood lap and V-rustic siding, along with cobble veneer wainscot. Windows are fixed and metal sliders, metal 1/1 double-hung, and wood 1/1 double-hung. Doors are one light panel. The rear (south) half of the building is 2½ story wood frame, occupied by apartments. Siding includes board and batten on the gable end. Windows are 1/1 metal double-hung, metal sliding, and fixed. Doors are flush. Building B is a rectangular L-plan wood frame house. The roof is cross gable with open eaves and exposed rafters, clad with rolled composition material with a dog-tooth edge to simulate shingles. A plastic sheet was secured over the roof with battens, but the plastic has decayed and been blown away. Walls are sheathed with wood lapped and V-rustic siding. Plywood skirting covers the foundation. Windows are 1/1 and 2/2 wood double-hung and two aluminum sliders. Doors are wood panel with one light. It appears that the east wing was added to the original structure, but this addition appears to date to the 1950s.

P5b. Description of Photo:
090-134-002, Building A, View SW.
Roll KBB7, Fr. 1. 01-20-03, 10:15 AM.

*B6. Construction History: Assessor does not have dates for the buildings. A building is shown in this location on the 1955 USGS map. Modifications (c.1990s) to Building A include a new addition, siding, windows, doors, and roofing. Modifications (c.2000s) to Building B include foundation skirting, windows, trim, and roof battens.

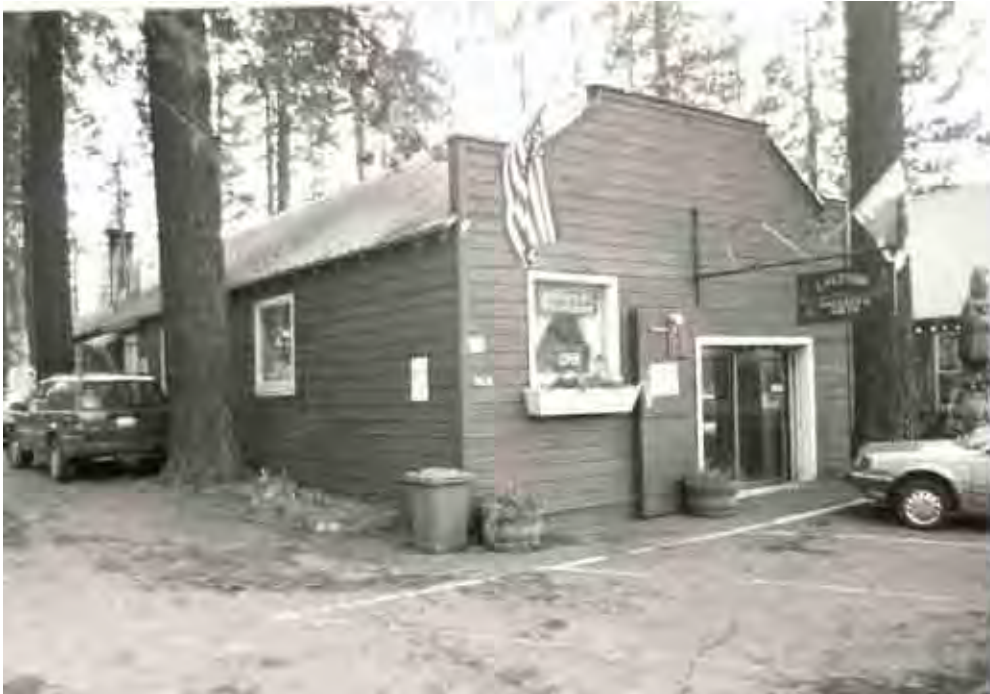
Building A is a one-story rectangular plan wood frame store presently occupied by the Lakeside Gallery and Gifts. It has a jerkin-head roof with false front, open eaves, and exposed rafters, clad with recent metal panels. Walls are sheathed with wood drop rustic siding. Windows are wood 6/6 double-hung and recent fixed. Doors are recent metal sliders. (continued)

P5b. Description of Photo:
090-134-005, Building A, View SW.
Roll KBB4, Fr. 11. 11-14-02, 3:36 PM.
